1.0 Bluewater

Bluewater Site Long-Term Custody Compliance Requirements

Bluewater Site Inspection Results

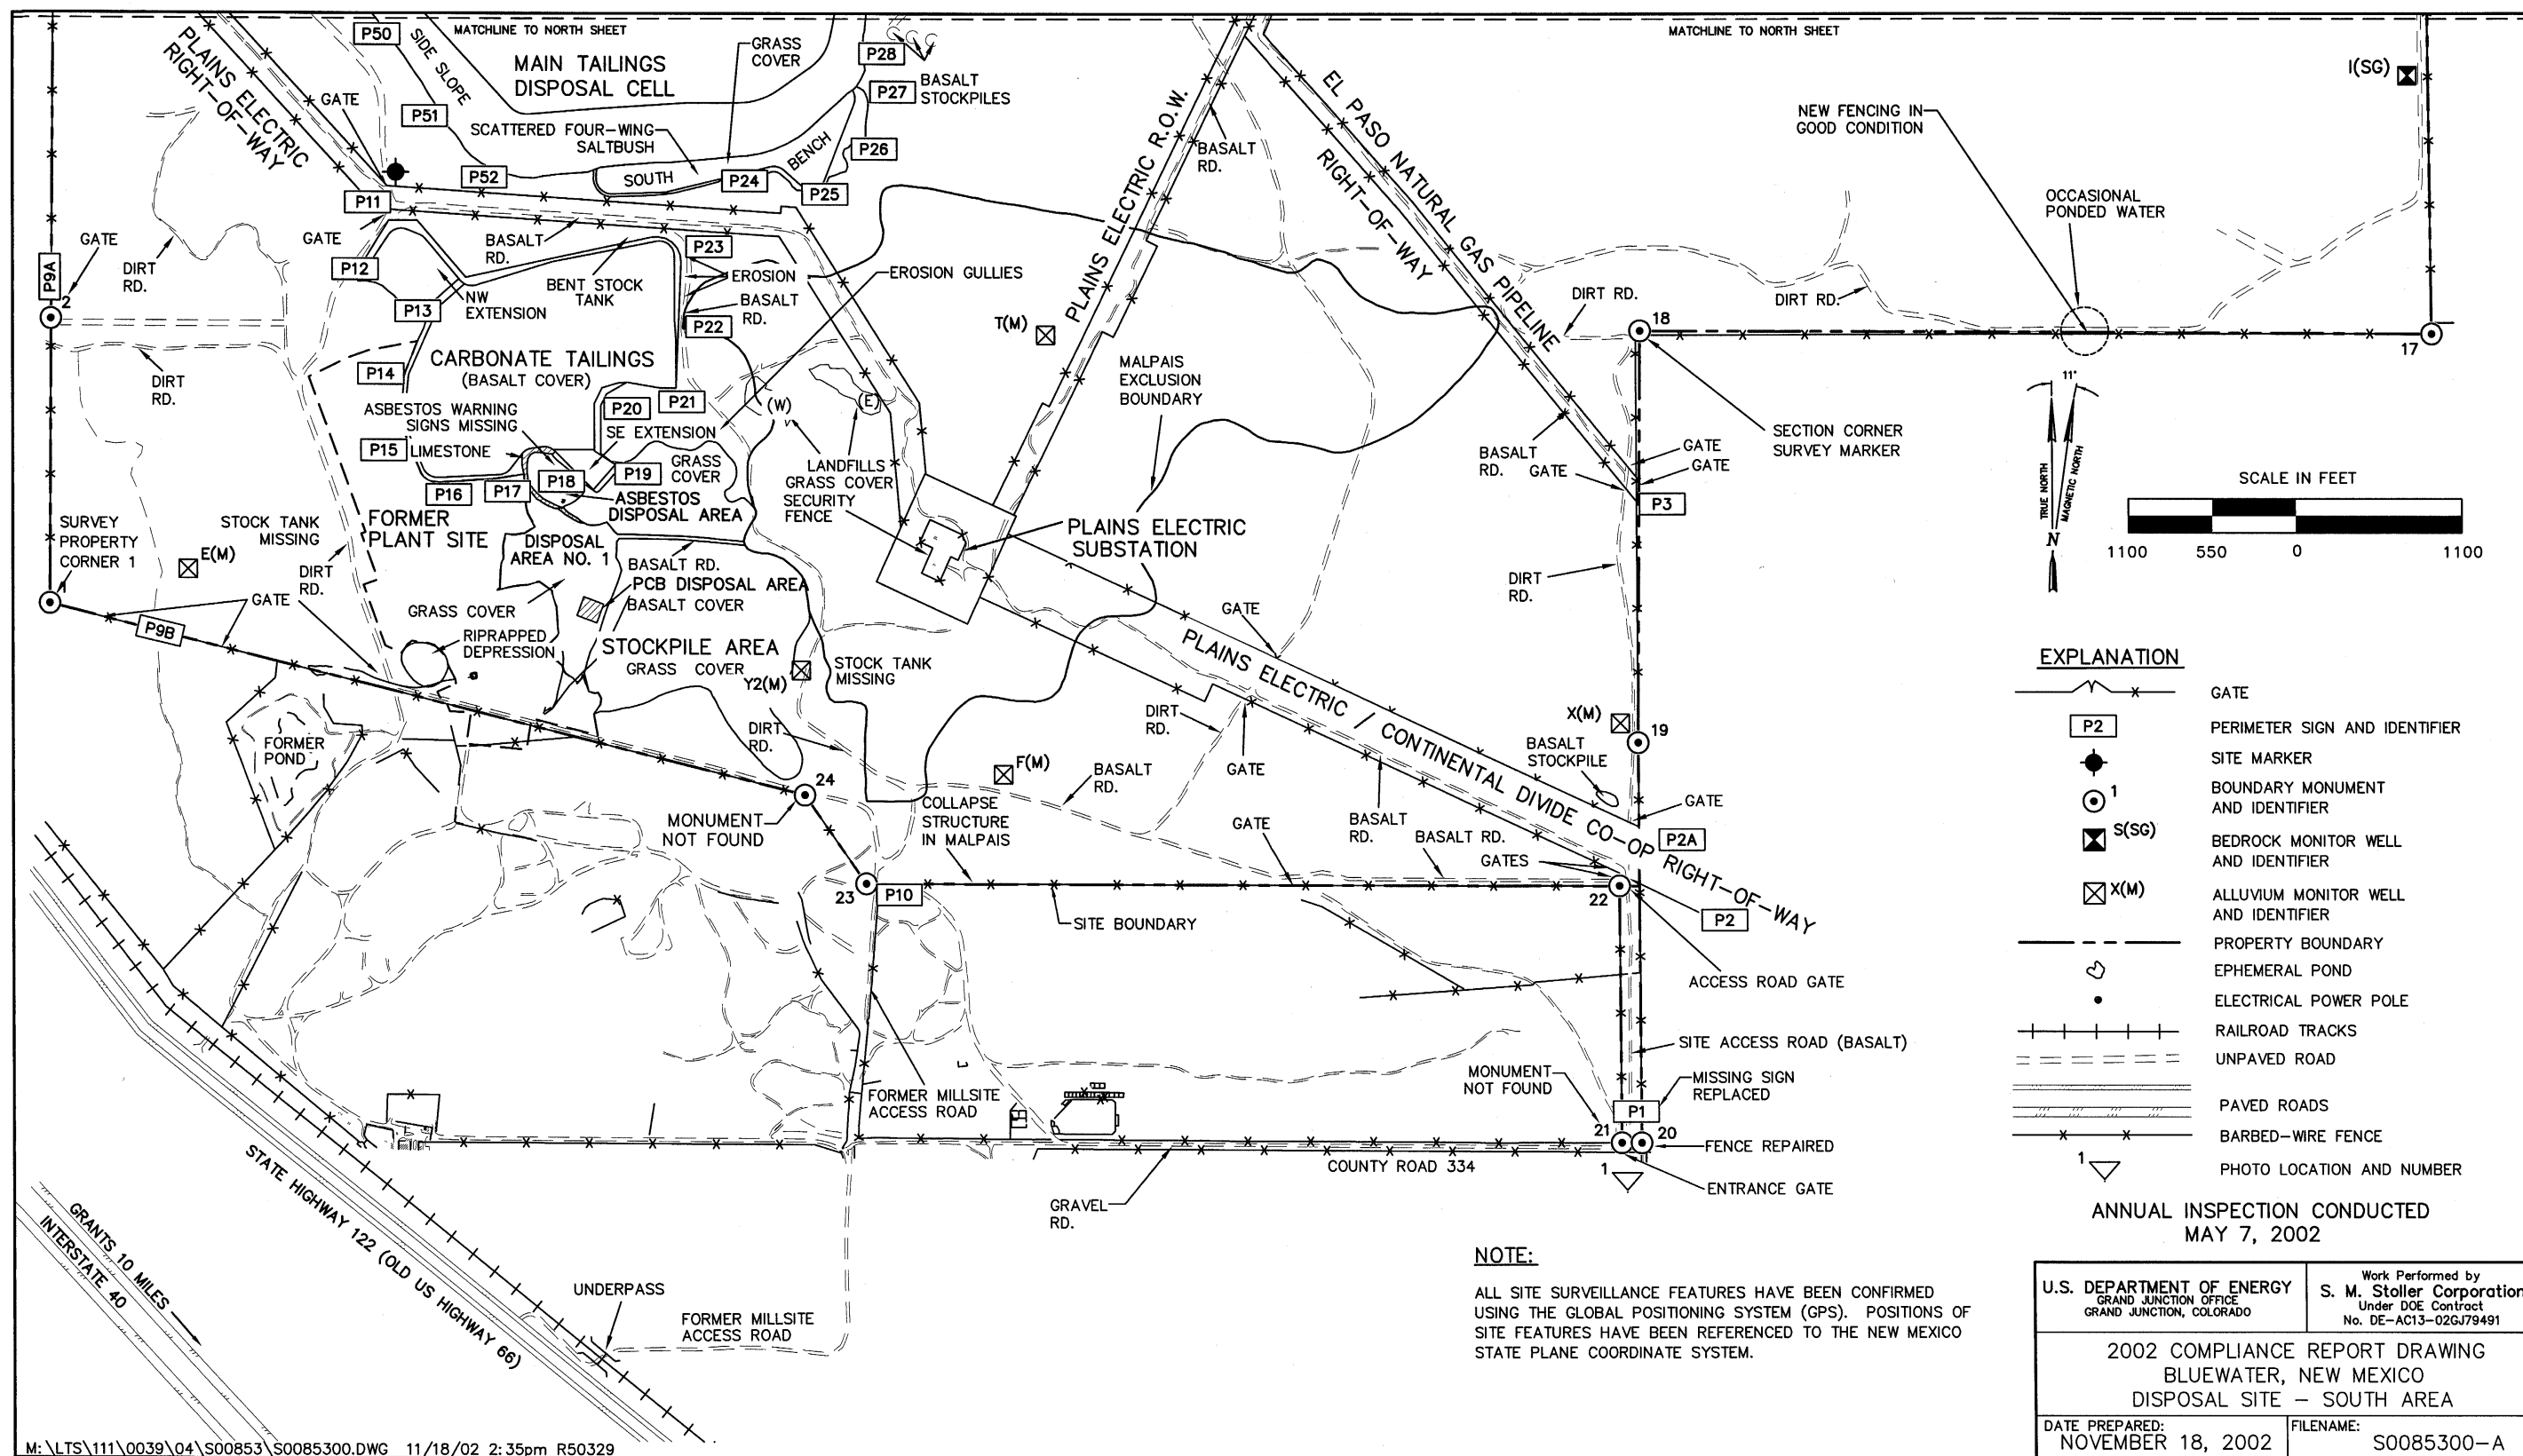
Figure 1-1. Bluewater, New Mexico, South Area, 2002

Fifty-four perimeter or warning signs, designated P1 through P52 on Figures 1–1 and 1–2 (including perimeter signs P2A, P2B, P9A, and P9B), are posted at access points along right-of-way intersections with the site boundary and around the main and carbonate tailings disposal cells. At the Bluewater site, all signs are identical and convey the information typically conveyed on entrance signs at other Long-Term Surveillance and Maintenance (LTSM) Program sites. Perimeter sign P1, located at the access gate, was missing; inspectors replaced P1 (PL–1).

The top and side slopes of the carbonate tailings disposal cell are covered by basalt riprap (Figure 1-1). The top, for the most part, slopes gently eastward. The small northwest and southeast extensions slope in their respective directions. The carbonate tailings disposal cell and its extensions are in excellent condition. Erosion was observed along the east edge of the apron below the carbonate tailings cell during the 2001 inspection. Soil fill appeared to be washing away from the edge of the apron. This area was inspected in 2002 and remains unchanged. This does not affect the performance of the apron at this time but inspectors should continue to monitor the area.

An electric power substation is enclosed by a security fence near the center of the site along the Plains Electric Company right-of-way (Figure 1-1). Fencing around this station generally is in good condition.
